Proposed Developments at the Former Carmelite Convent  
Delgany, County Wicklow

## **Conservation Report and Heritage Impact Assessment**

**September 2020**

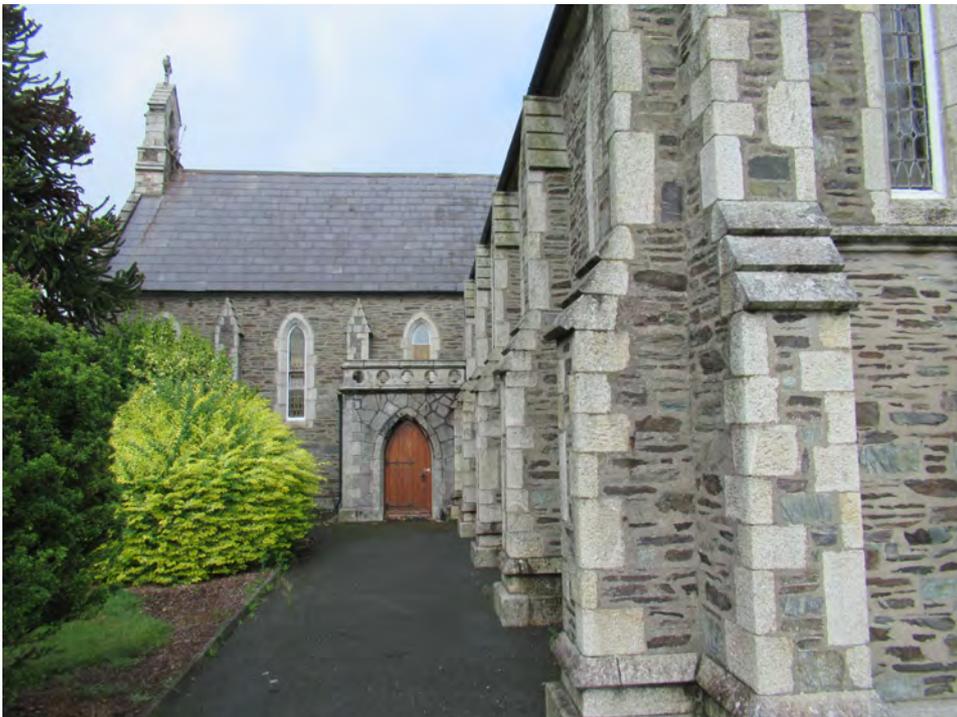
Plate No. 9. Detail view of the chapel, looking west, showing the details of the rubble stone walls and granite corners, coping slabs and plinth courses.

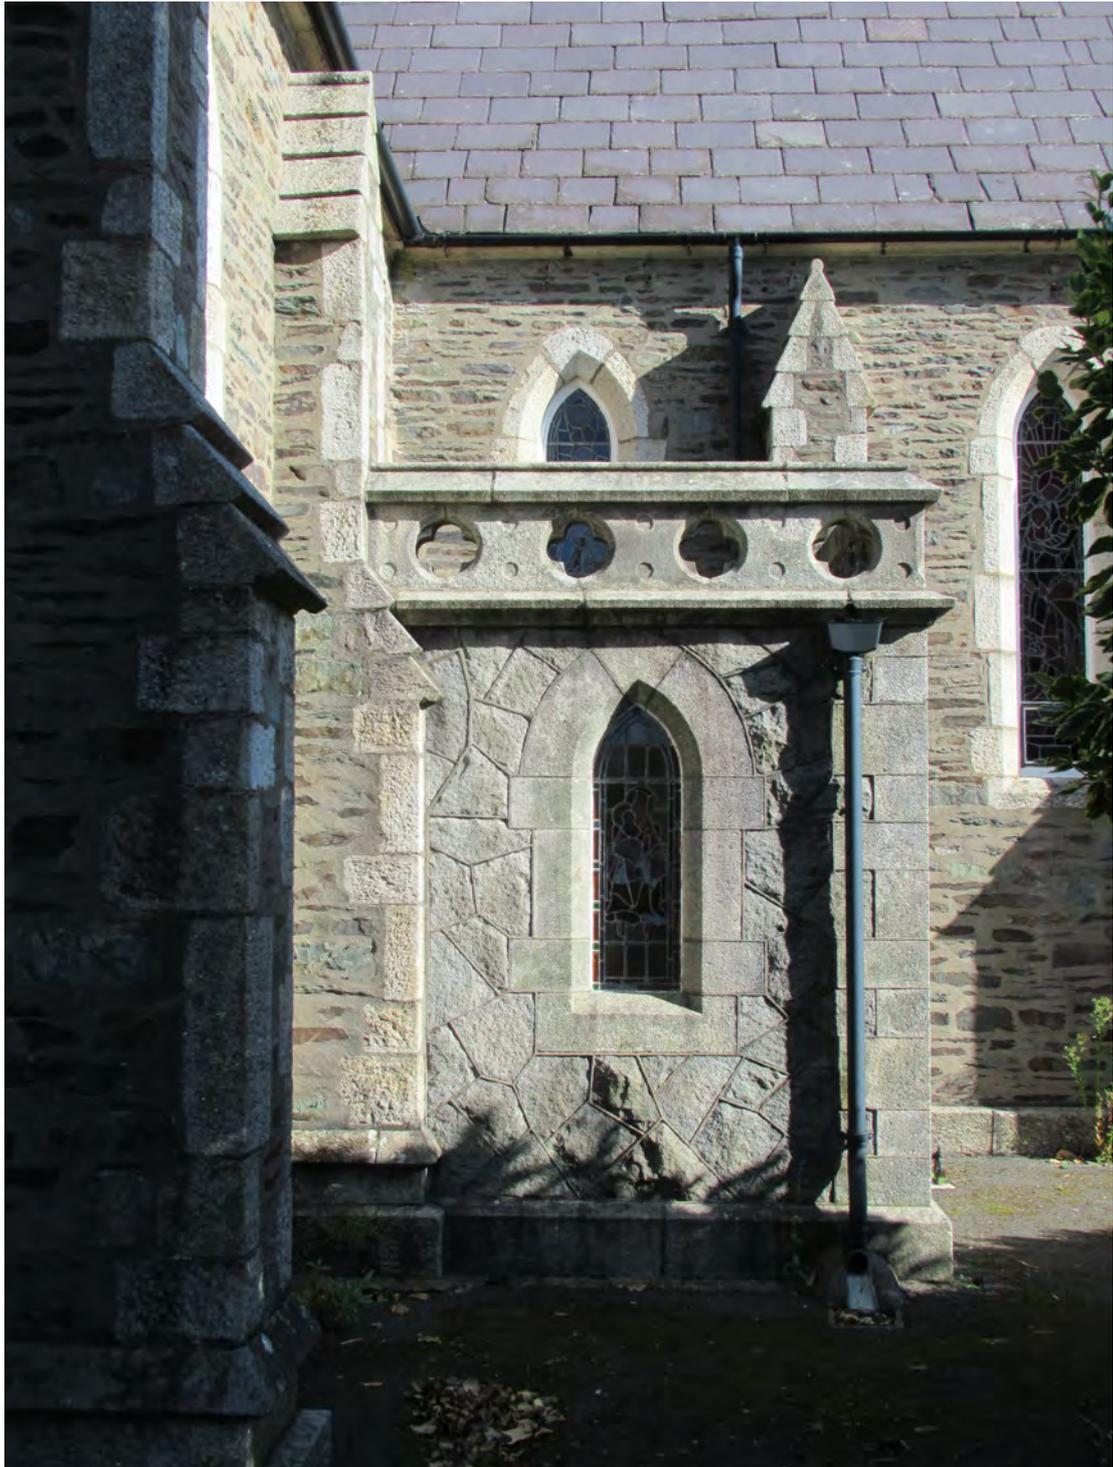
The chapel appears to be in very sound condition, however some past repairs should be readdressed in future programmes of work. The original lime pointing has been covered up throughout the external wall surfaces, by a wide smooth mortar of Portland cement and sand. This has changed the character of the external masonry, and will lead to increased moisture levels within the historic walls. A small number of structural cracks were noted to the external walls, that will require further investigation by a structural engineer with experience in traditionally built structures.

Plate No. 10. Detail view showing the small porch on the south side of the chapel. Note the use of granite for all of the dressed stones, and also for the tightly fitting randomly shaped stones around the lancet window. Note also the extent of the poor quality sand and cement pointing used on the joints to the rubble stone masonry.

The basic structure appears to be in sound condition, however some of the past repairs should be revisited in the near term. The poorly conceived cement pointing should be removed from the external masonry, and replaced with vapour permeable lime and sand pointing. A structural engineer with expertise in working with historic structures will be engaged to comment on the cracks noted to the chapel walls. The roof slates are in need of some patching, and will eventually need to be carefully stripped and re-hung because of rusting fixings. At that time, it would be advisable to improve the insulation of the roof structure, and introduce additional ventilation controls. Additional electrical and heating services will be required for whatever new use is agreed, along with the introduction of toilets and back of house spaces.

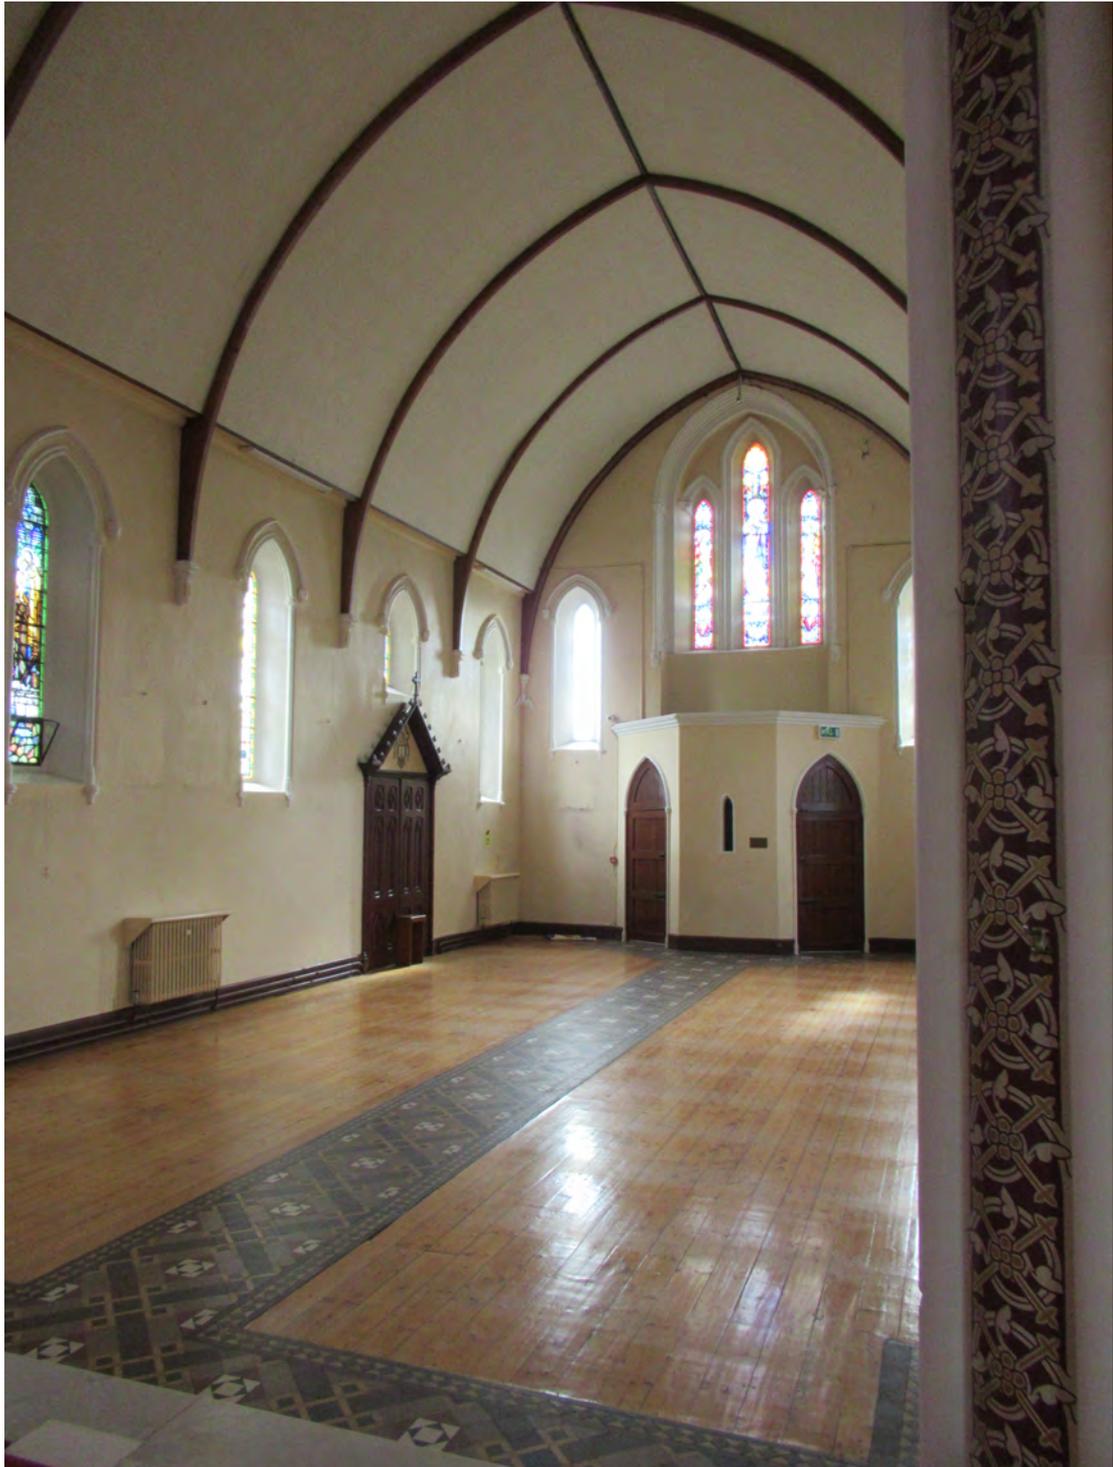
Plate No. 11. Internal view in the chapel, looking east. The pews have all been removed, leaving the original timber and tile flooring. Note the cast iron radiators and exposed heating pipes.

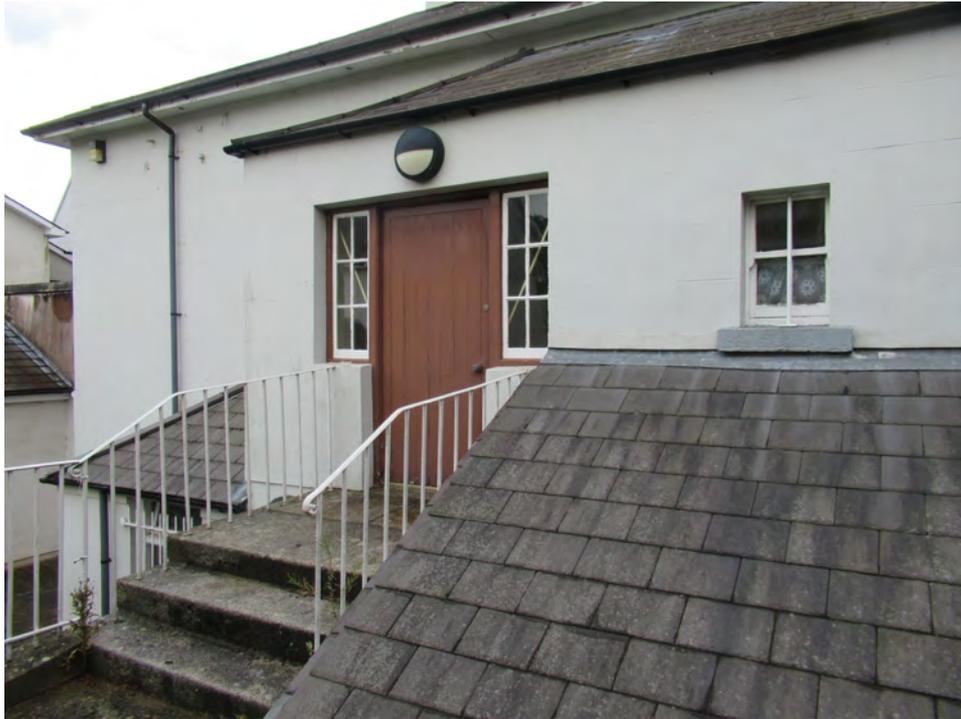
Plate No. 18. Detail view showing the stone stairs and iron railings on the rear of the house. The roof to the right covers a boiler room at the basement level, and is not an original part of the house.

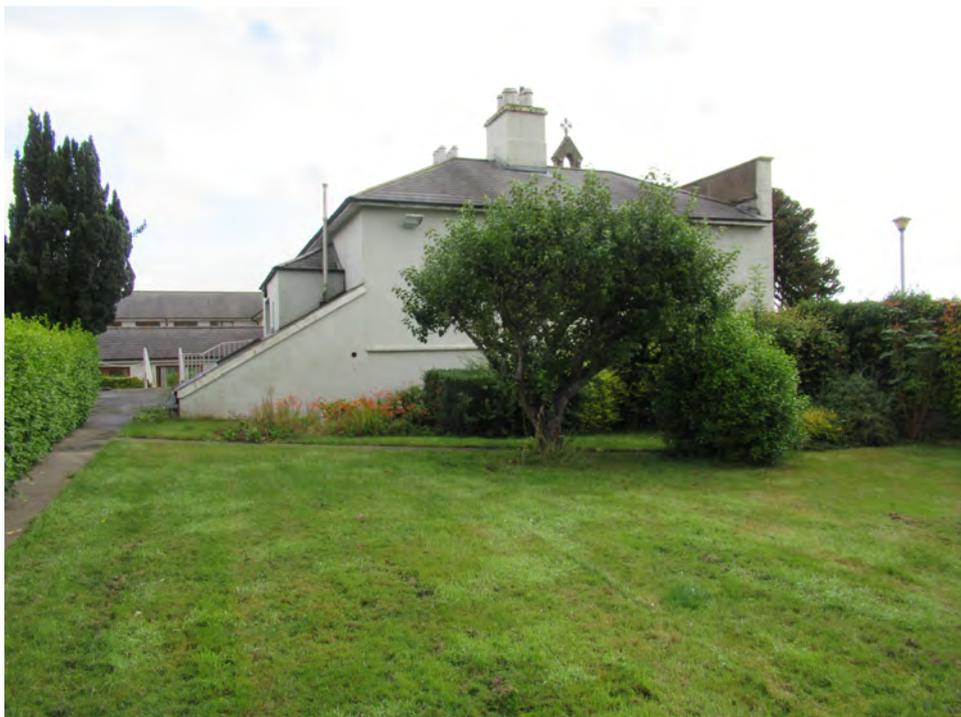
Plate No. 19. General view of the south elevation of the house. Note the high front parapet, probably added to the original house when the now demolished school building was built during the middle of the nineteenth century.

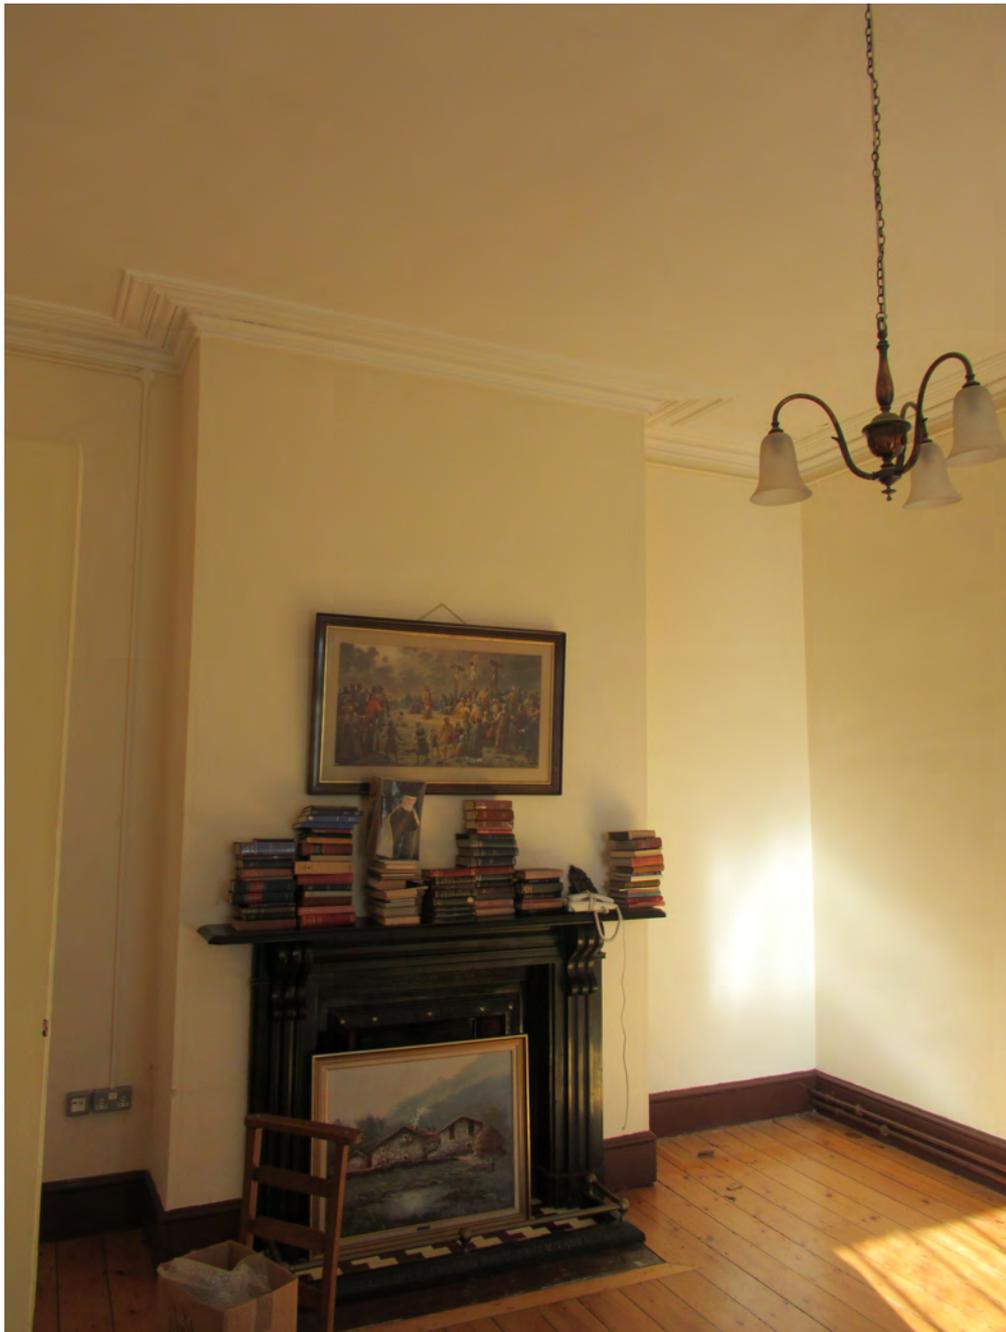
There are many indications that the house underwent a significant programme of repairs to address chronic roof leaks in the rear roof valley. The ceilings in the rear upper floor rooms have been replaced, and their plaster covings removed. The original valley ran down the centre of the house, over the stairwell, and has now been covered up with a flat roof. Other modifications include a change of detail to the roof eaves, and replacement of the original natural slates with fibre cement tiles. Most of the external walls appear to have been covered with cement rich render, replacing the original dashed lime render. Otherwise, it appears that this structure has retained most of its architectural features and design.

Plate No. 21. Detail view showing the features in the front north room in the house. The moulded stone fore surround, timber floor and good quality cornice are original to the house's construction around 1845, and should be retained. Similar features remain in the other room across the hall, and in the rear south room. The ceilings in the southern half of the house were replaced over the last decade or two, due to chronic roof leaks.

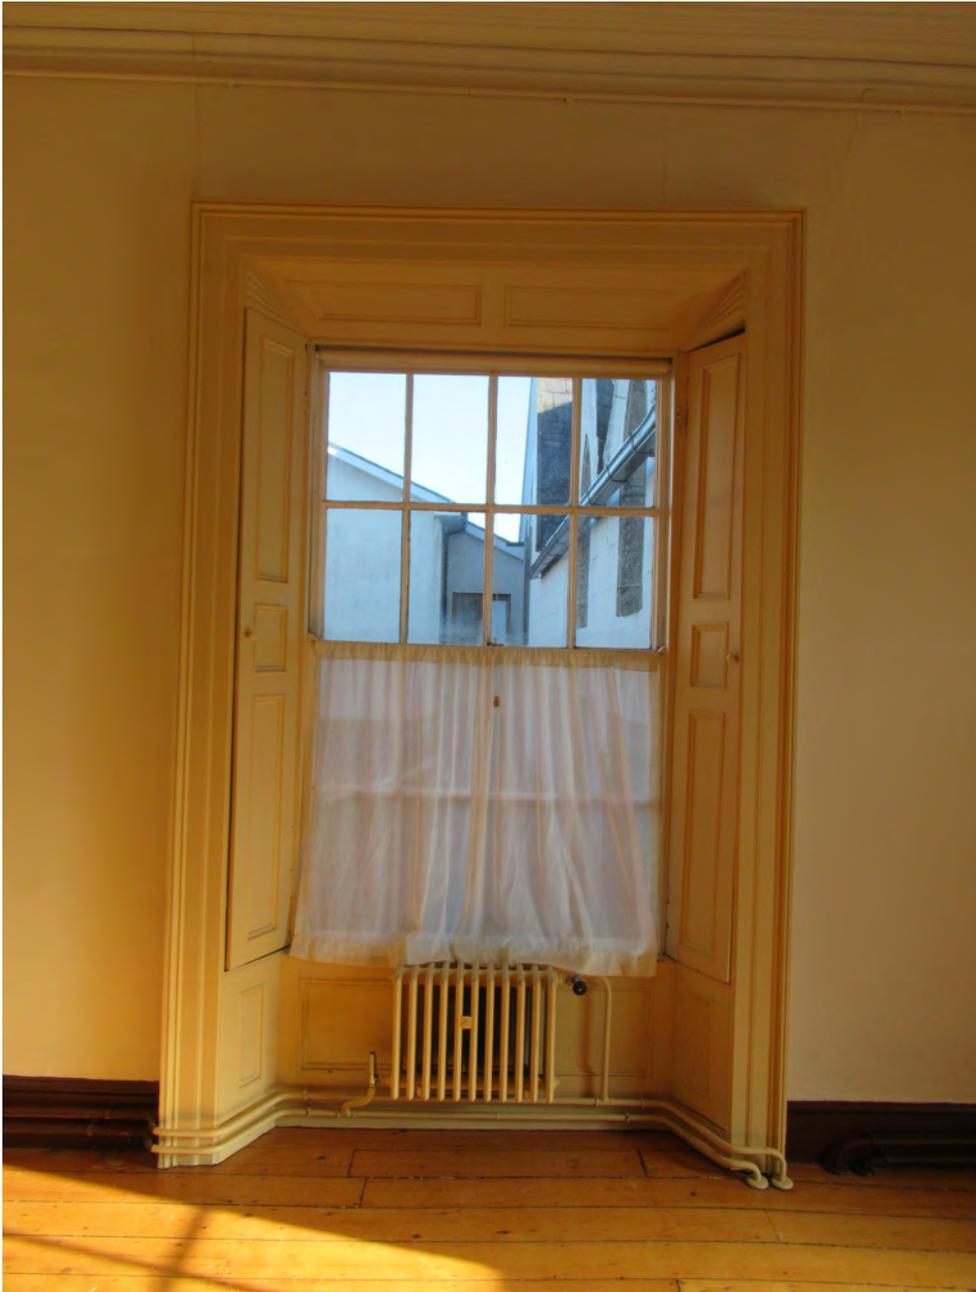
Plate No. 22. Detail view showing the original sash window and internal joinery, in the upper floor north rear room. This window is typical of all of the upper floor windows, and retains all of its original joinery.

Repair and maintain the original timber sash windows. The installation of thin double glazing and draught seals should be considered to help retain heat.

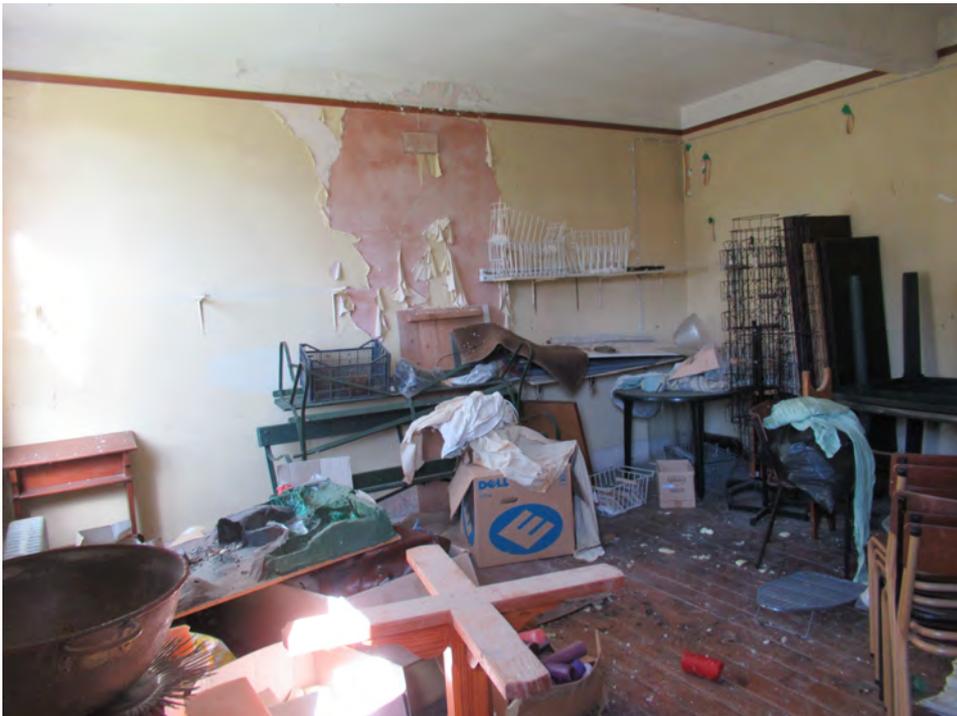
Plate No. 28. Internal view in the oratory, showing its simple construction and poor current condition.

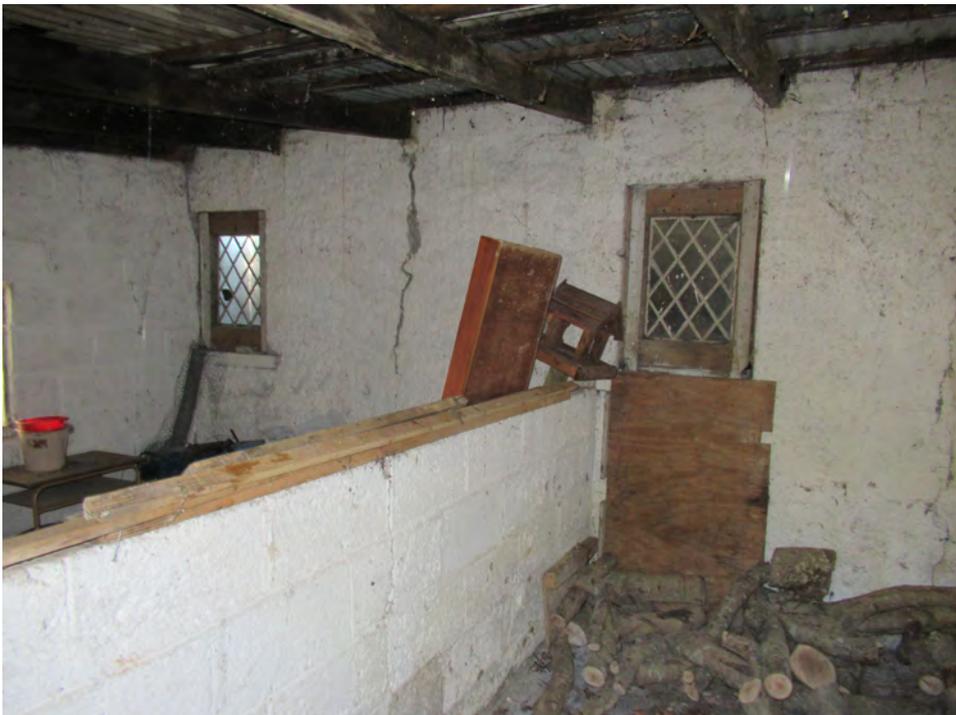
**The stable building has some degree of value as an interesting example of a vernacular farmyard building from the middle of the 19<sup>th</sup> century. It is in very poor condition and because of its low ceiling heights it would be very difficult to find a viable new use. At a minimum, these features should be recorded in photographs and a measured survey drawing.**

Plate No. 32. Internal view showing the typical internal features and conditions in the stable building. There is widespread rot and insect damage to all of the timber elements. The external walls have cracked and spread outward at the top, due to the gradual failure of the roof structure.

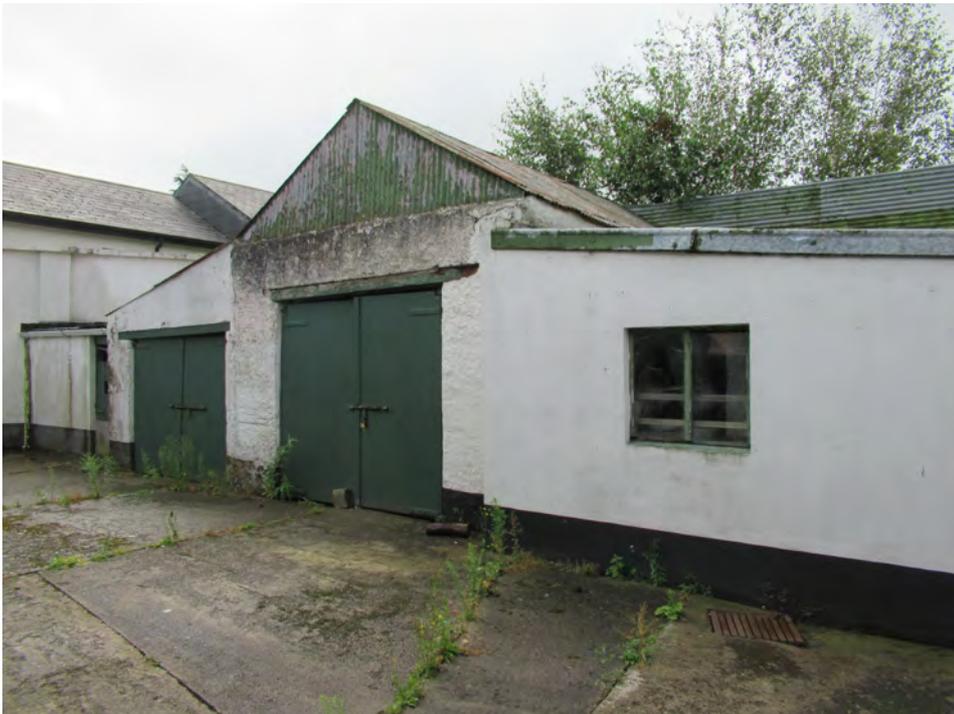
Plate No. 34. General view looking south showing the sheds in front of the stable building. These shed consist of rendered concrete blocks walls with corrugated steel roofs and wall cladding.

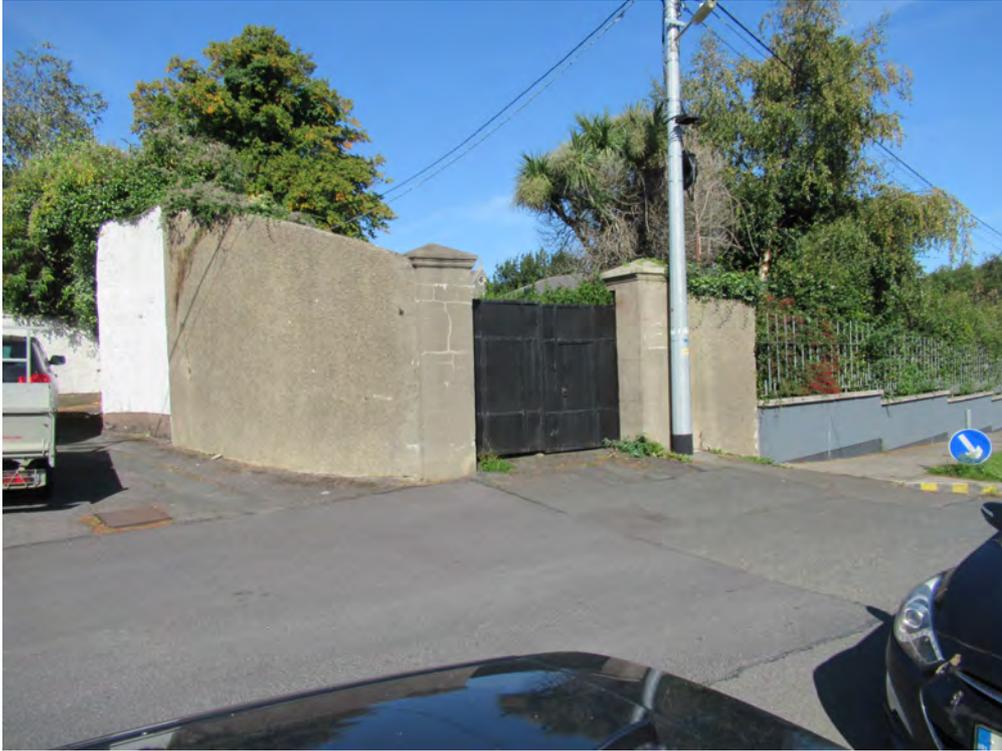
Plate No. 37. Detail view showing the nineteenth century entrance gates at the front of the property. The gate lodge is behind the iron sheeted gates.

It is proposed to retain a pedestrian entrance through the south-east corner of the site, adjacent to the 19<sup>th</sup> century gate lodge. The existing iron sheeted gates are of no significance and are hung within cement-rendered rubble stone piers. To allow for greater visual connections between the village and the Protected Structures, it is proposed to replace the gates with more visually transparent gates. New gates will be hung from rebuilt masonry piers, following the Architect's details contained in their planning drawings.
