Proposed Developments at the Former Carmelite Convent  
Delgany, County Wicklow

## **Conservation Report and Heritage Impact Assessment**

**September 2020**

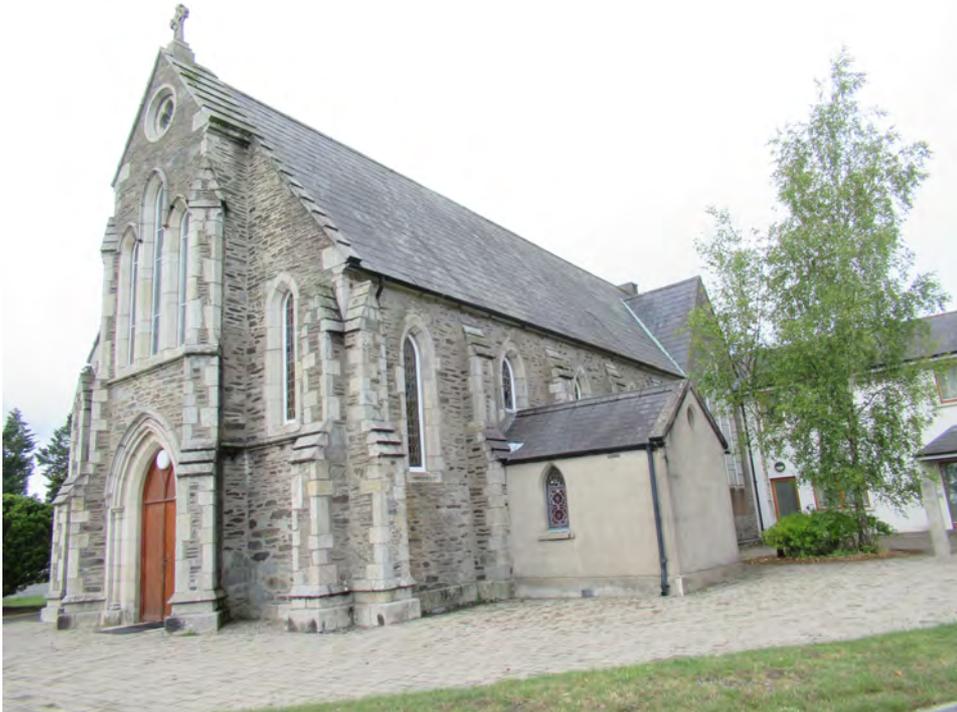
and the early twenty-first century development to the rear. The small north extension has a slated roof, but its walls consist of cement rendered concrete block. It has no particular architectural significance but was sensitively detailed and sited. The rear extensions have no architectural significance, and because they are to the rear of the chapel, they could be retained or replaced, to provide service spaces for the proposed creche.

Plate No. 7. General view of the chapel from the northeast showing its general composition. The small side extension probably dates from the middle decades of the twentieth century. The 21<sup>st</sup> Century convent structures can be seen to the right, attached to the rear of the Chapel.

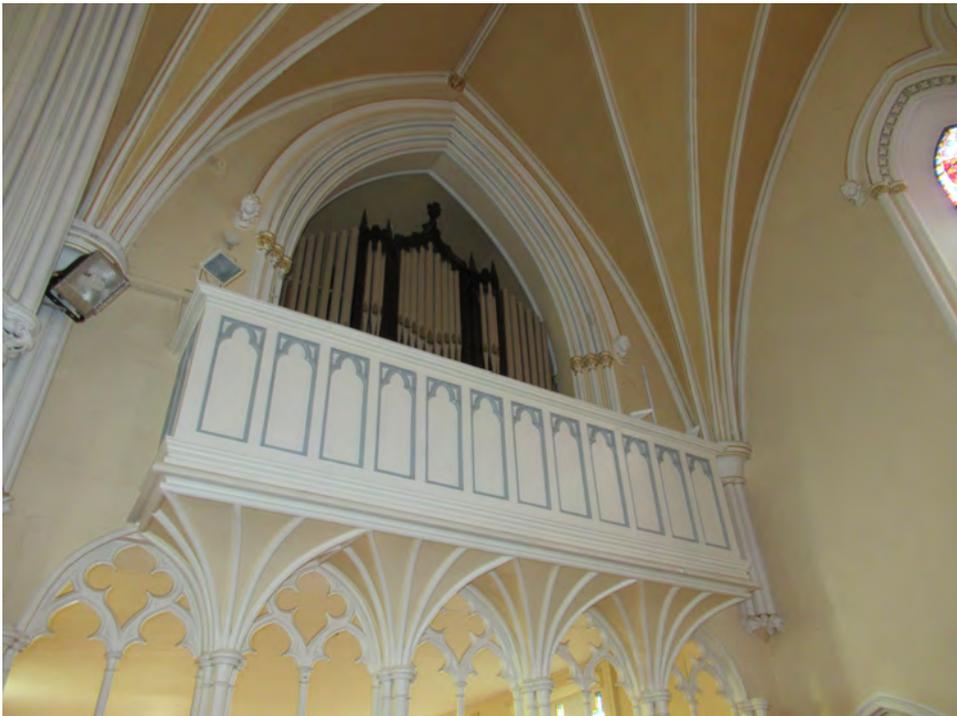
Plate No. 13. Detail view showing the beautifully crafted plaster and carved timber details to the organ loft and screen.

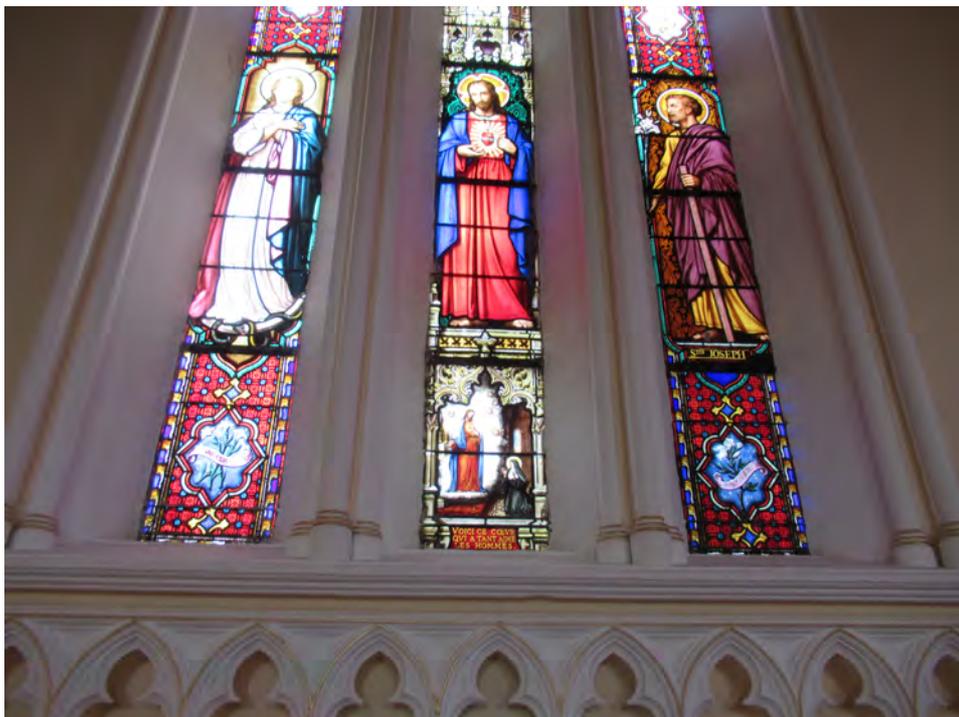
**There are many fine stained glass windows in the chapel, with at least a few being the work of Harry Clark, the famous Dublin stained glass artist of the early 20<sup>th</sup> century. The ownership of those important windows was retained by the Carmelite Order, and was always their intention to remove the windows for reuse in another appropriate setting. Planning permission was recently granted for this to be carried out.**

Plate No. 15. Detail view showing some of the remaining stained glass in the west window over the altar area.

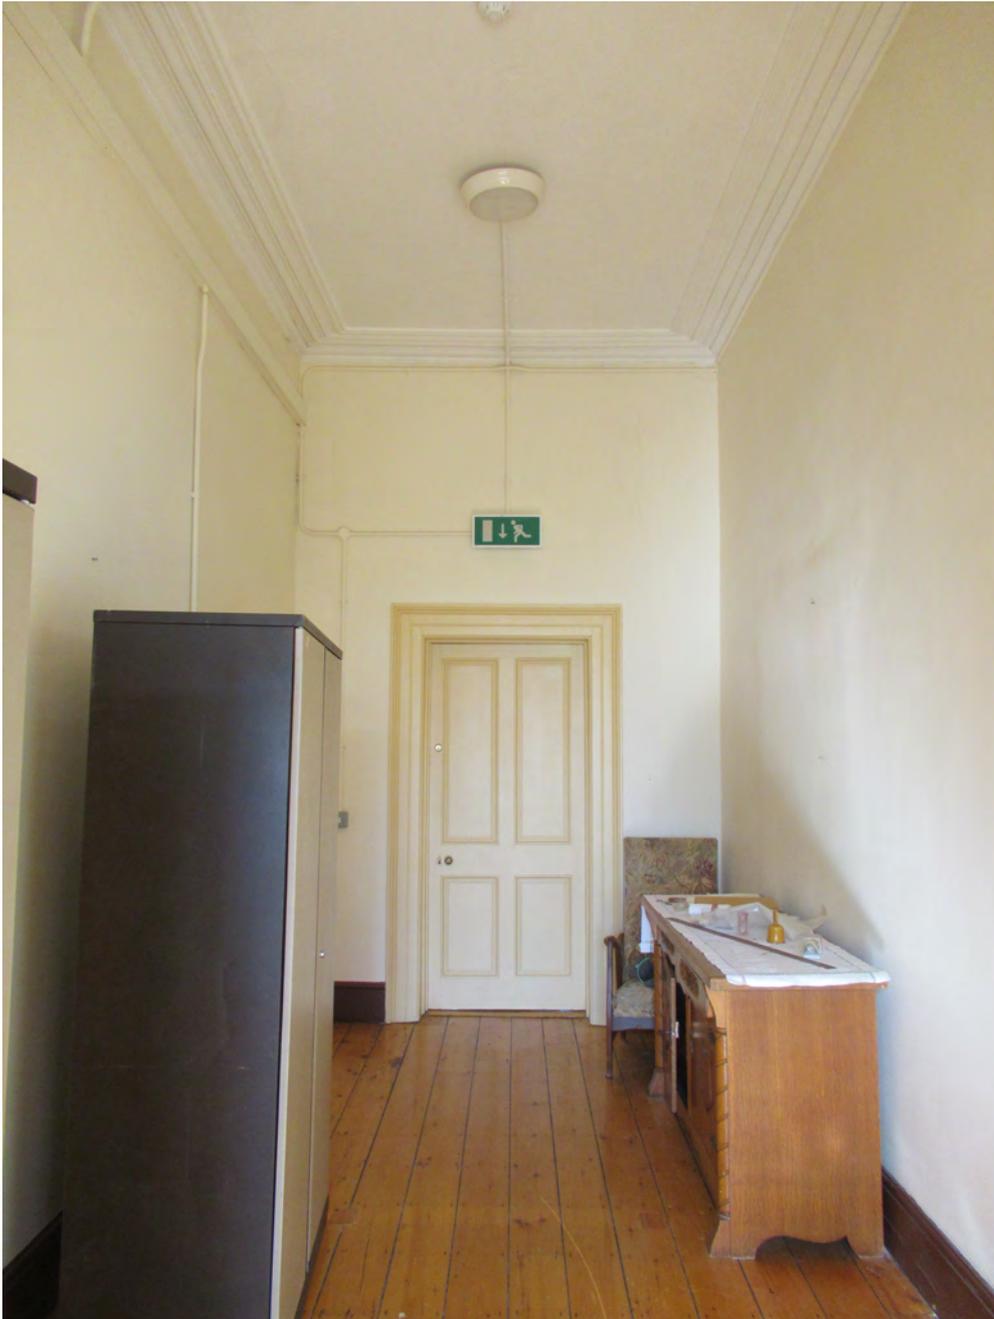
Plate No. 20. General view showing the raised ground floor entry hall. Note the timber floor boards, moulded architrave and panelled timber door and plaster cornice around the wall head. These are all typical features in an early Victorian suburban house and should be retained.

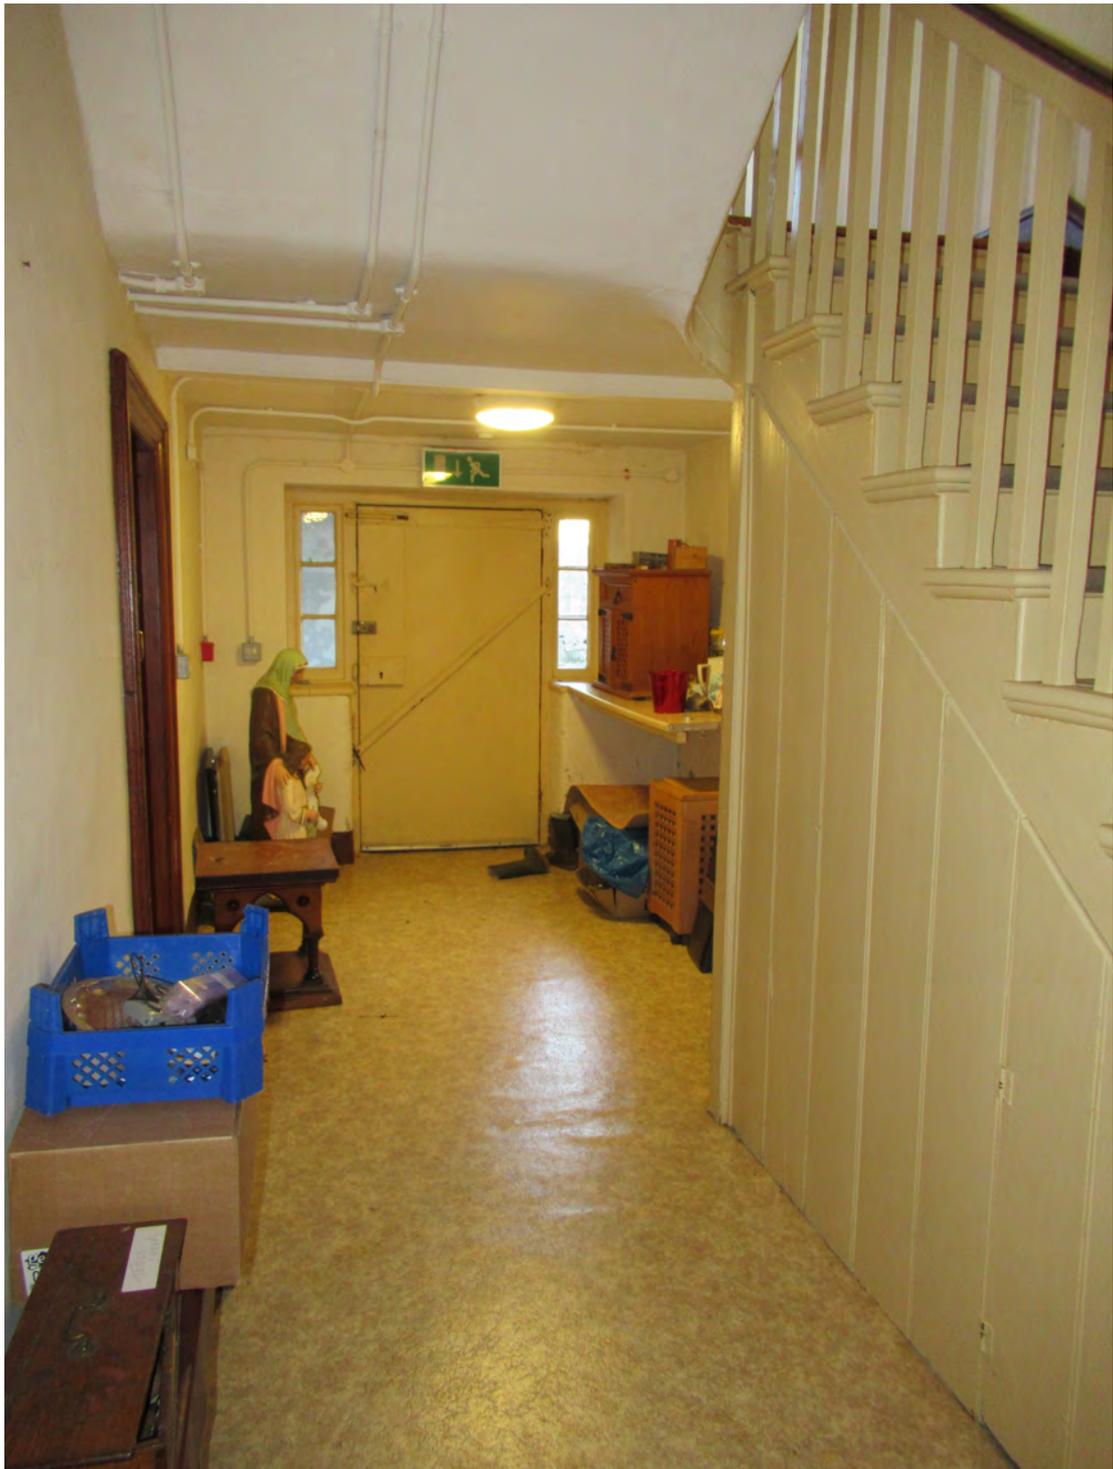
Plate No. 24. Detailed internal view looking to the rear in the lower ground floor. The floor is covered by sheet lino. The stairs, doors and rear sheeted door are all original features from the mid-nineteenth century.

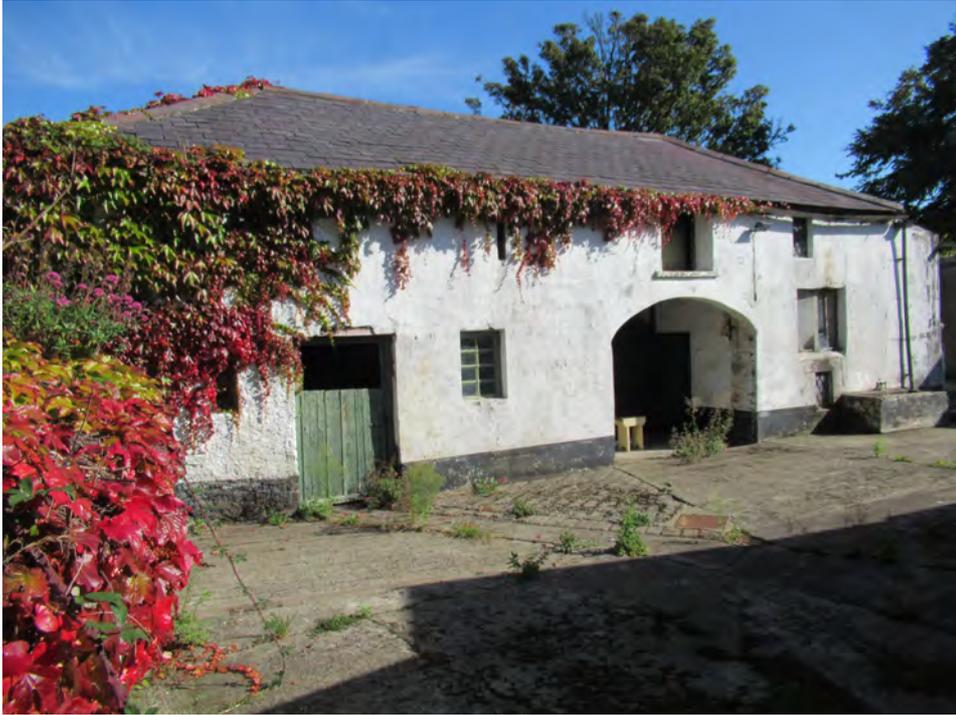
**The stable building has some degree of value as an interesting example of a vernacular farmyard building from the middle of the 19<sup>th</sup> century. It is in very poor condition and because of its low ceiling heights it would be very difficult to find a viable new use. At a minimum, these features should be recorded in photographs and a measured survey drawing.**

Plate No. 31. General view showing the mid-nineteenth century stable building in the yard to the south of the house.

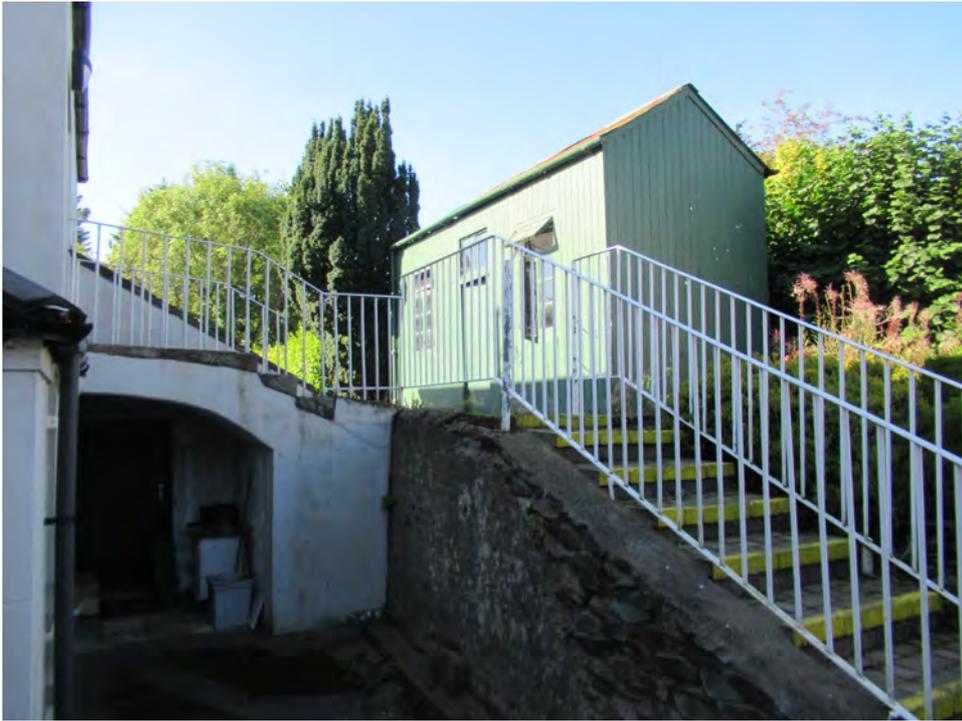
**Apple Store.** Standing behind the nineteenth century house is a small single storey apple store, a once common structure found in walled gardens and orchards. This particular store was built of timber studs, and covered with painted timber boards, with a simple corrugated steel sheeted roof. The store probably dates from the middle decades of the twentieth century, and has a modest degree of interest as a vernacular garden structure.

Plate No. 39. General view showing the small timber apple store behind the Victorian house.

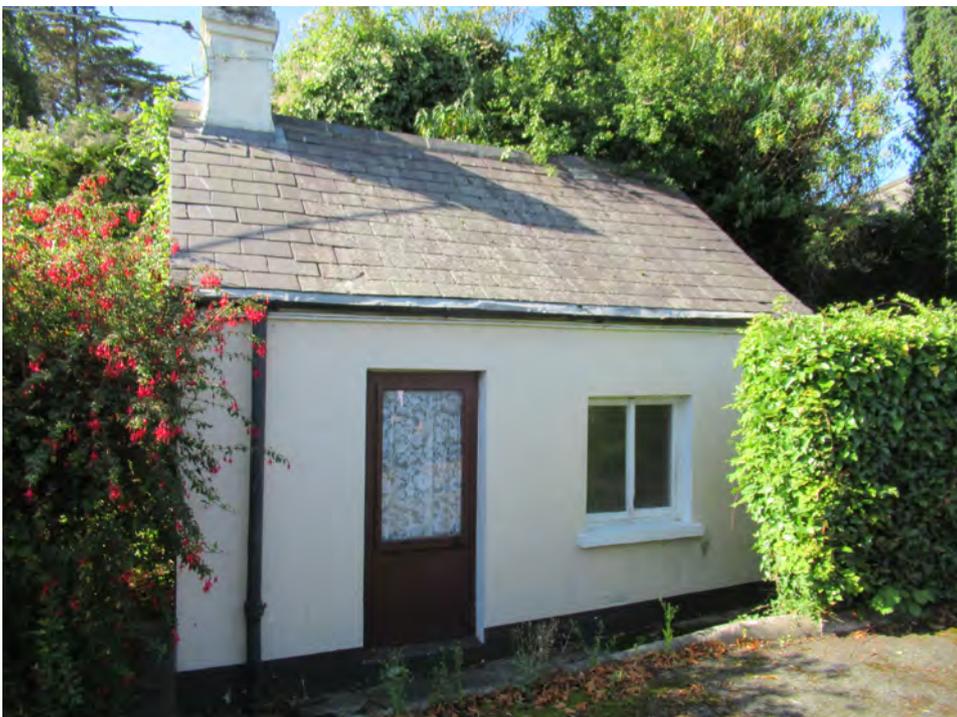
The gatelodge is a modest and simple example of the kind of small lodges that were used throughout Ireland as a home for full time staff and immediate security at the entrance gates. This gatelodge remains in useable condition and provides a tangible link to the property's 19<sup>th</sup> century origins and its long use as the enclosed home of a religious order.

Plate No. 40. Detail view showing the north front elevation of the nineteenth century gatelodge, close to the original front entrance gates.

The lodge should be treated with sensitivity in the proposed development. Because of its location close to the centre of Delgany, it is proposed to sensitively repair the lodge to serve as a management office for the new estate. The external envelope will be carefully repaired using traditional roof slates, timber sash windows and lime based renders. There are no internal features of note in the gatelodge.

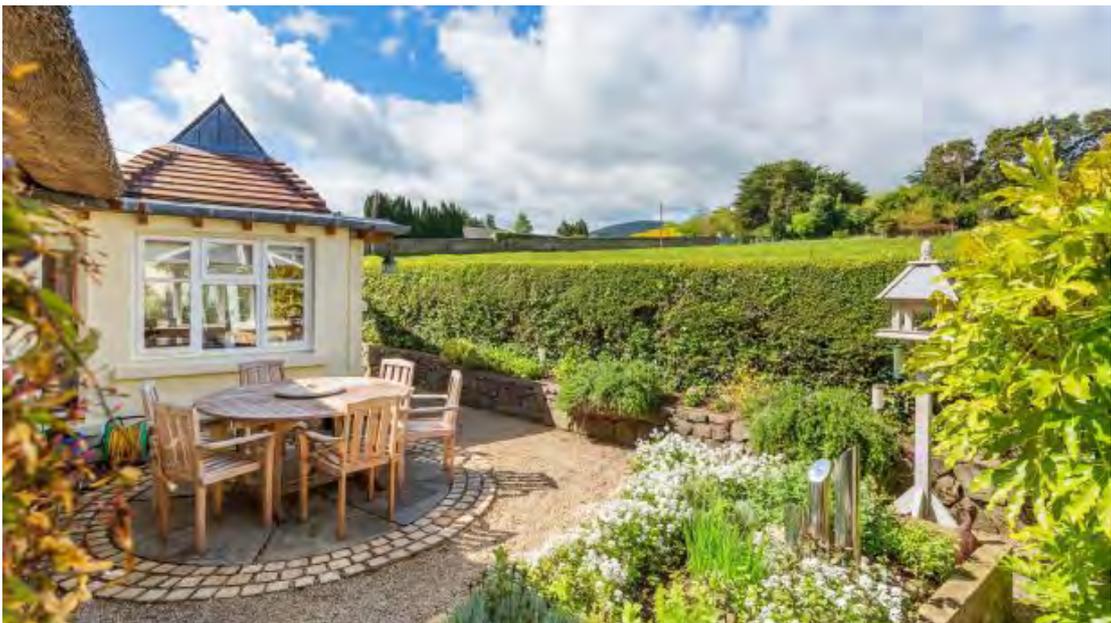
Plate No. 42. General external view showing the rear boundary behind Creech Barrow, looking across the boundary into the site of the propose development. In the proposed development, there will be a row of semi-detached bungalow on the other side of this boundary, with the new houses' rear gardens backing up to the shared boundary. This will help to mediate the scale of the new development where it abuts existing houses, in particular this interesting structure.
